CONDITION ASSESSMENT REPORT
of the
NORTH SHORE PARKING GARAGE
Pittsburgh, Pennsylvania

August 7, 2017

O&S Associates, Inc.

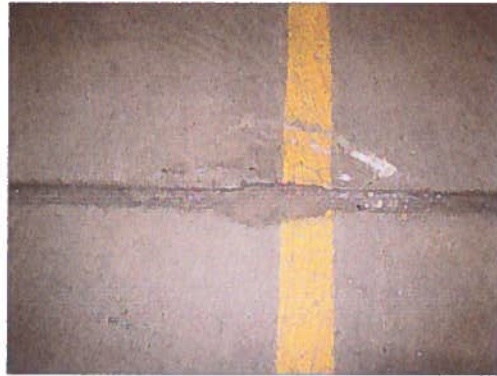
SLAB SPALLS AT TEE-TEE SHEAR CONNECTORS

Several slab spalls were visually identified located above the steel tee-tee shear connector assembly along the edges of precast tees, indicating the shear connector may be corroding. The shear connectors are important structural elements that transfer vehicular load across the tee joints and connect the slab diaphragm.

Chain drag sounding should be provided along all tee-tee joints to locate all of the spalls and delaminations at the shear connectors. Provide concrete patch repairs at each of the spalls (Line Item #4) and delaminations, including cleaning corroded shear connector steel and any exposed slab reinforcement free of corrosion deposits and painting with a protective rust inhibitive coating. Replacement of failed sealants (Line Item #12/#17) and shotblast cleaning & sealing the floor slabs with water repellant sealer (Line Item #19) will go a long way to protect the shear connectors from future corrosion damage.

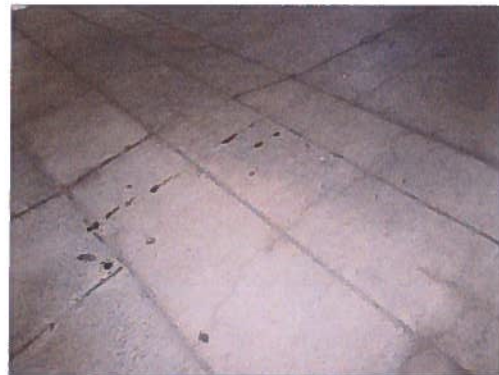
CRACKING, SPALLING, AND DEBONDING AT POUR STRIPS

Many of the CIP pour strips are suffering deterioration, including cracking, debonding of the pour strip from the underlying precast girder/double tee slab, spalling and scaling. The pour strips tie the individual precast structural elements together while providing a suitable driving surface.

We recommend patch repairs and/or removal and replacement of the deteriorated sections of pour strips (Line Item #5), with provisions for new control joints above the precast beam-tee/tee-tee joints. Cracks at locations of sound concrete should be routed and sealed. The girder pour strips at turning bays should be shot blast cleaned and protected with a traffic bearing waterproofing membrane (Line Item #16) to reduce the rate of scaling and structural deterioration. All other pour strips should be protected with a water repellant surface sealer at the less deteriorated and less vulnerable locations.

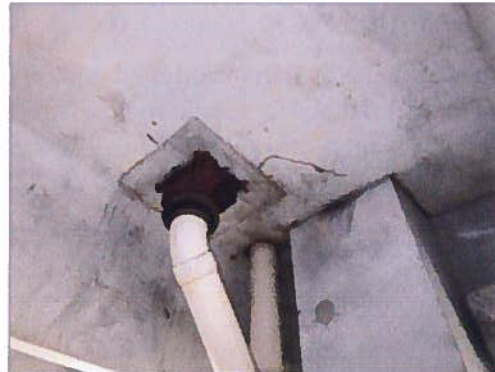
OVERHEAD SPALL AT FLOOR SLAB SOFFIT

A few isolated locations of overhead spalls were observed at the floor slab soffits, due to moisture seeping through the slab and causing corrosion of the embedded reinforcing steel. The locations we identified in the field are generally under the locations of CIP pour strips and at areas of corroding slab shear connectors.

Provide overhead patch repairs (Line Item #6) of the floor slab soffits, etc. at the locations of overhead spalls/delaminations. Patch repairs will include removing and replacing the loose concrete, cleaning and painting corroded, embedded steel reinforcement and providing new hooked anchors for additional bond capacity of the patch.

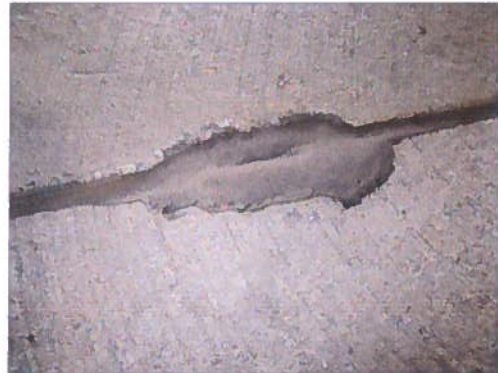
AGED AND DEBONDED TEE JOINT SEALANT

All of the parking garage tee-tee joint sealants are near the end of their useful service life. The sealants are beginning to debond and leak, especially at the locations of the tee-tee shear connectors. Leakage through the slab causes the embedded connectors to corrode, and leads to corrosion related spalling of the structural double tee. Leakage is also a nuisance to garage patrons.

We recommend complete replacement of all of the floor slab sealants throughout the garage (Line Item #12/#17). This can be done on a scheduled basis over a few years to reduce annual budget impacts if needed.

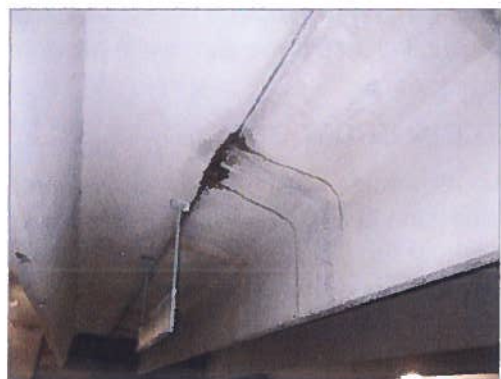
THRU SLAB LEAKAGE ALONG TEE JOINTS

We observed leakage at the tee-tee joints due to failed slab sealants. Leakage through the slab causes the embedded connectors to corrode, and further deterioration of the concrete tee flange edges.

We recommend removal and replacement of the floor slab sealants (Line Item #12/#17). It should be noted

that the sealant replacement at the roof level will require replacement of traffic bearing membrane along the tee joints to maintain membrane continuity, as it will be damaged during the sealant replacement process.

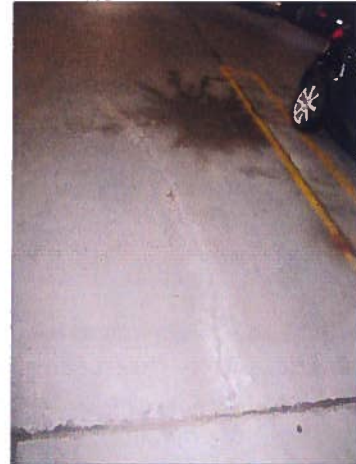
FLOOR SLAB CRACKS

Numerous floor slab cracks were identified along the pretopped floor slabs. Many of the cracks have been previously repaired using an epoxy filler; however, some cracks were open and unprotected. Slab cracks are conduits for water seepage into the slab, which can lead to corrosion of reinforcing steel and subsequent concrete delaminations and spalls.

We recommend routing and sealing the floor slab cracks with caulk sealant (Line Item #13) to prevent the ingress of moisture into the cracks.

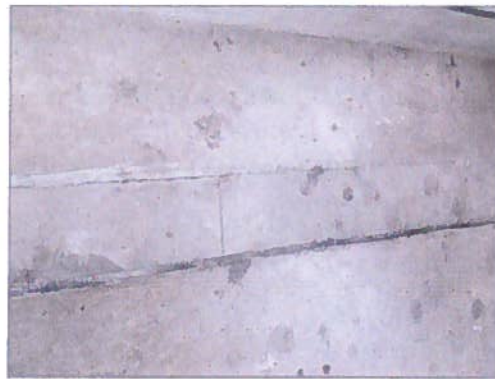
CRACKED AND DEBONDED POUR STRIPS AT PRECAST STAIRS

Nearly all of the pour strips at the precast stairs have cracked, debonded and spalled. Some additional spalls were identified around the pour strips due to water seepage around the perimeter of the pour strip. The spalls and debonded concrete indicate underlying steel connections may be corroding. The steel connections are important structural elements as they connect the individual sections of the precast stairs & landings together.

The debonded and cracked pour strips should be removed and replaced (Line Item #8). Once the concrete has been removed and the underlying steel connections are exposed, the steel should be protected with a rust inhibitive coating. In order to prevent future damage, we recommend the pour strips are coated with a pedestrian grade waterproofing membrane.

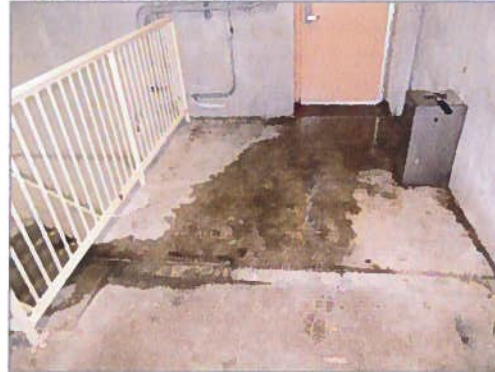
LEAKAGE INTO STAIR

We observed some water ingress into the stair. Generally this was a nuisance issue at this time, however some corrosion of the metal railings and some instance of minor spalls appear to possibly be caused by the moisture ingress. The leakage could eventually lead to structural spalls and

delaminations of the precast stairs, etc.

We recommend that new, supplemental drains be provided in front of the stair tower doors to collect the water and prevent seepage into the stair tower (Line Item #21). It should be noted that some drains have already been installed in front of some of the stair tower doors.

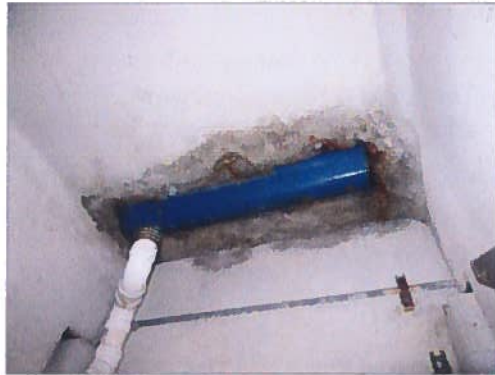
LEAKAGE AT DRAINS

Supplemental (assumed) drains in front of some of the stair doors were observed to be leaking. The leakage appear to be occurring between the drain and the slab, and not the drain itself. Concrete deterioration along the perimeter of the drains were observed.

We recommend routing and sealing the perimeter of the floor drain (Line Item #23). If this does not have the effect of repairing the leak, the drain may need to be removed and reset.

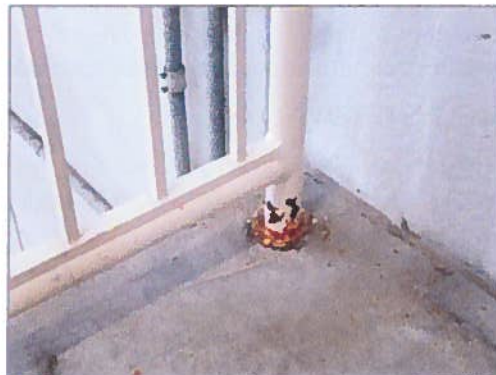
CORROSION AT STAIR RAILING

Corrosion damage at several of the stair railing supports was observed. This is unsightly and allowed to progress, will eventually fail the railing support.

We recommend cleaning the railing free of corrosion damage and painting the corroded sections of the railing with protective rust inhibitive paints (Line Item #22). The rest of the railing appear to be generally in good conditions, and comprehensive repainting of all railing is not needed at this time.

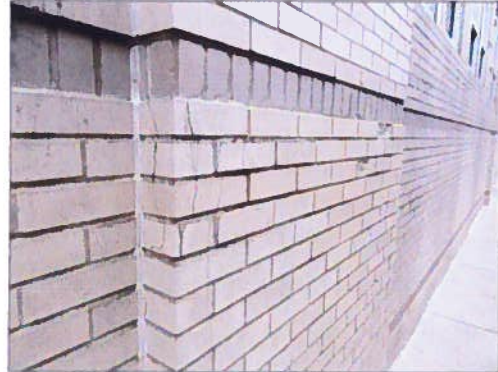
CRACKED AND SPALLED BRICK AT FAÇADE

Face brick masonry has cracked and spalled throughout the first and second floor façade of the parking garage. The spalled face of the brick is a potential falling hazard and the damaged bricks allow water to penetrate the façade and exacerbate the rate of deterioration of the façade. It should be noted that the majority of the deteriorated face brick is located at the 1st and 2nd floor façade.

We recommend that the spalled and cracked bricks be replaced (Line Item #7), and the façade be protected with a water repellent sealer (Line Item #14 & #18). A masonry sealer will reduce the amount of water absorption and reduce the rate of future deterioration of the masonry wall. If desired, a short term solution of removal of the spalled brick faces can be performed to mitigate the falling hazard if immediate funds are not available for the replacement of the deteriorated brick.

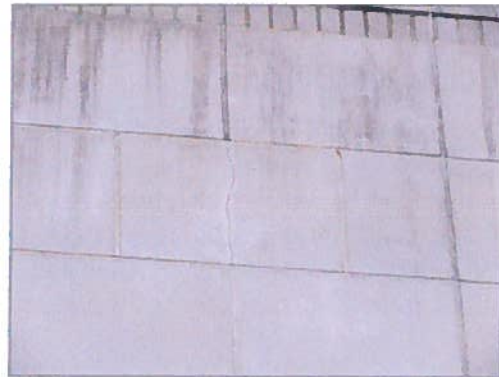
CRACKED STONE PANEL FAÇADE

Several of the stone blocks located along the front elevation of the façade have cracked. The cracked stones allow water to seep into the façade causing further deterioration of the wall.

The cracked stones should be removed and replaced (Line Item #10), followed by protection with a water repellent surface sealer (Line Item #14). If a lower cost option would be desired, the cracks could be routed and sealed with a new polyurethane sealant; however this option is generally considered unsightly and is not recommended.

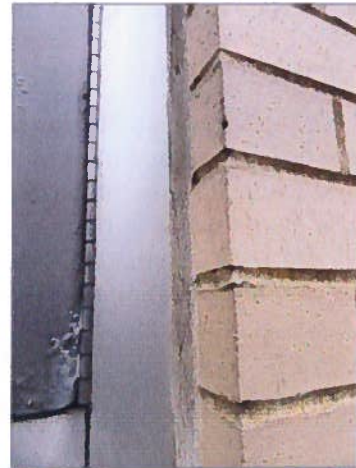
CRACKED AND DEBONDED FAÇADE SEALANTS

All of the façade sealants have failed at this time. Failed sealants are a direct access point for water to penetrate the façade, causing damage to structural connections, and possible deterioration of interior finishes in occupied spaces.

The façade sealants require comprehensive replacement at this time (Line Item #15).

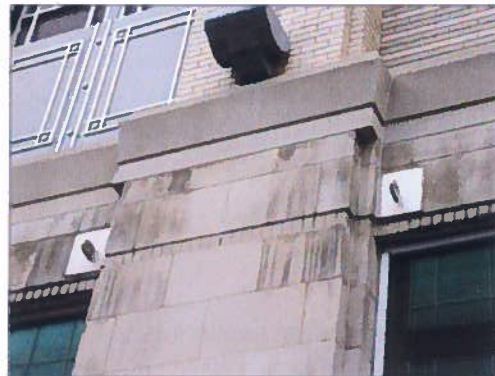
STAINED STONE PANEL FAÇADE

Staining due to dirt, grime, water and organic growth was observed at the stone façade. Primarily at ledges and reliefs where water can be retained. The condition is unsightly, and indicated saturation of the stone, which may cause deterioration over time.

The stone should be powerwash cleaned with a proper stone cleaner to remove as much of the existing staining as possible (Line Item #14). The stone should then be sealed with a water repellent sealer to protect the stone and also reduce the rate of future staining. It should be noted that cleaning of stone is partly a trial and error process and that some of the staining is likely "set-in" and will not be able to be removed without complete removal of the stone.

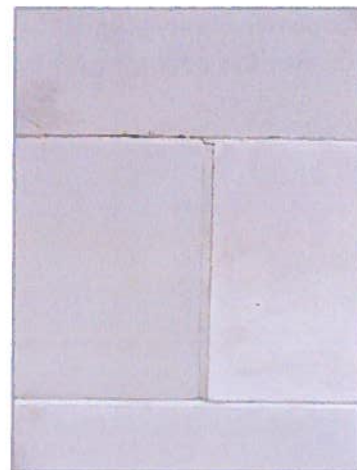
CRACKED AND DEBONDED MORTAR JOINTS

Several cracked and debonded mortar joints were observed at both the brick and stone façades. Cracked and debonded mortar joints are a main source of water entry into the building walls and also is a weakening of the overall strength of the façade.

We recommend repointing the cracked and deteriorated mortar joints using a properly engineered mortar mix (Line Item #9/#11). After the mortar joints are repointed, the façade should be sealed and protected with a water repellent surface sealer (Line Item #14 &

#18), which will protect the mortar joints and reduce the rate of future deterioration.

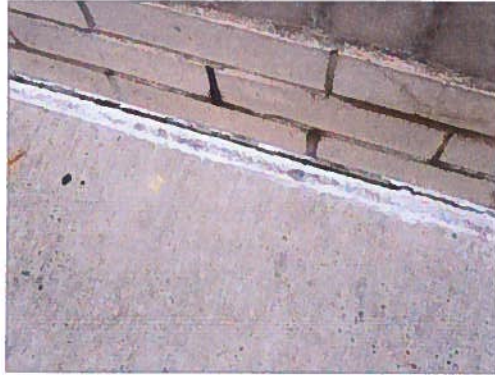
CRACKED AND DEBONDED SEALANT AT SIDEWALK

Caulk sealants at the joint between the sidewalks and the garage façade have failed. The open joints allow water to penetrate causing deterioration of the brick masonry, and concrete sidewalk and potentially the foundations.

We recommend replacement of the sidewalk joint sealants (Line Item #15).

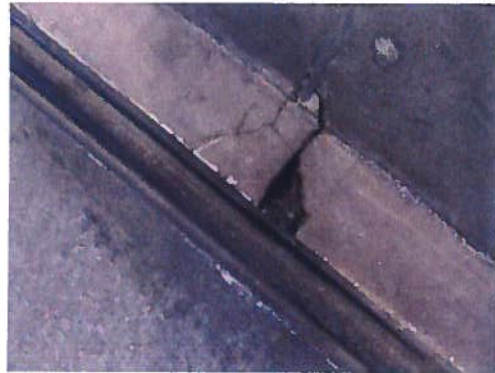
DETERIORATED AND SPALLED NOSING AT EXPANSION JOINT SEAL

The nosing along the expansion joint between the slab-on-grade and supported floor slabs has cracked and spalled. This condition is likely allowing leakage through the seal, which may lead to structural deterioration along the joint.

We recommend removal and replacement of the nosing compound (Line Item #20). Once the nosing has been removed, the seal can be inspected and may be determined that it also needs to be replaced.
