CONDITION ASSESSMENT REPORT
of the
WEST GENERAL ROBINSON STREET PARKING GARAGE
Pittsburgh, Pennsylvania

Submitted to:
STADIUM AUTHORITY OF THE CITY OF PITTSBURGH

August 7, 2017

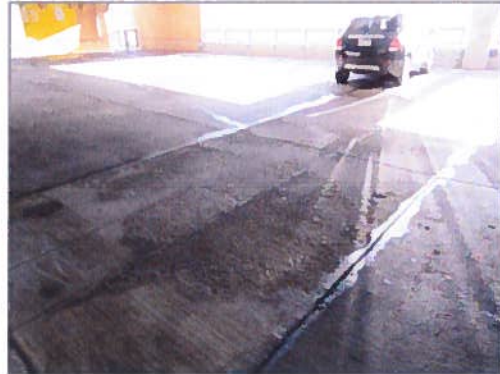
CRACKING, SPALLING, AND DEBONDING AT POUR STRIPS

The CIP pour strips are deteriorating, including cracking, debonding of the pour strip from the underlying precast girder/double tee slab, spalling and scaling. The pour strips tie individual structural precast elements together while providing a suitable driving surface.

We recommend patch repairs and/or removal and replacement of the deteriorated sections of pour strips (Line Item #4), with provisions for new control joints above the precast beam-tee/tee-tee joints. Cracks at locations of sound concrete should be routed and sealed (Line Item #10). The pour strips should then be shot blast cleaned and protected with a traffic bearing waterproofing membrane (Line Item #12) to reduce the rate of scaling and structural deterioration; and reduce water leakage and seepage below the pour strips.

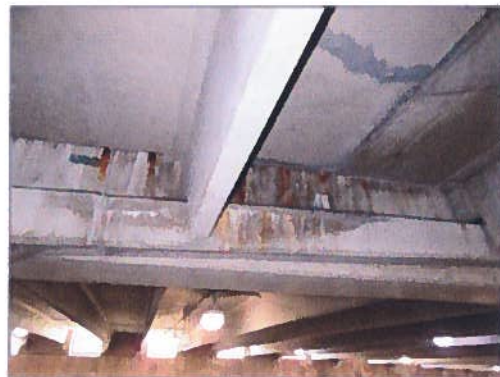
GIRDER LEDGE SPALL AT SLAB CROSS-OVER – LEVEL SEVEN

A large spall has developed along the girder bearing ledge under the intermediate crossover at the 7th level of the parking garage. Failed sealants and leakage through the CIP pour strip at the floor slab appears to have caused the damage to the inverted tee girder. Over time, the spall may continue to deteriorate and loss of bearing capacity of the double tee may occur.

We recommend the girder ledge be patch repaired, which would include cleaning and protecting the corroded steel reinforcement in the beam ledge (Line Item #5). The tee stems will need to be temporarily shored during the repair. The pour strip above the spall should be sounded for delaminations, and be patch repaired as needed (Line Item #4); followed by sealant replacement (Line Item #9) and application of a waterproofing membrane (Line Item #12) to prevent leakage through the slab.

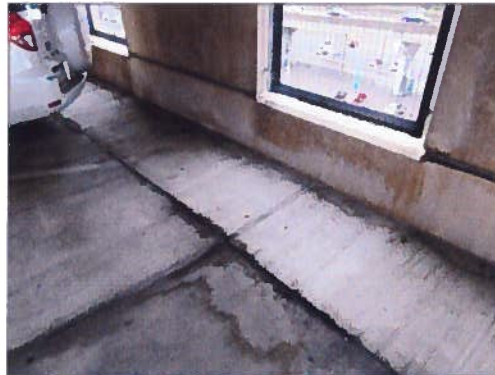
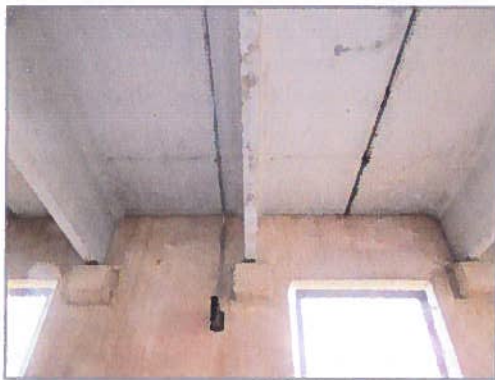
FAILED SEALANT, UNPROTECTED CONCRETE AND WATER ACCUMULATION ALONG JOINT BETWEEN POUR STRIP AND PRECAST SLAB

The existing drainage along the slab surface accumulates water along the joint between the pour strip and the precast topping slab. Failed sealants along the joint and lack of waterproofing is permitting water seepage into and under the pour strips. Efflorescence has developed under almost all of the cast in place pour strips (second photo) throughout the parking garage, due to the leakage through the unprotected & cracked slabs and failed sealants above. Over time, the moisture seepage will lead to extensive debonding of the pour strips from the structural Tee flange, as well as corrosion of structural steel connections and reinforcement.

We recommend replacement of all of the sealants at the pour strips (Line Item #9), followed by application of a waterproofing membrane (Alternate A1). If a reduced cost option is desired, the curb pour strips may be sealed with a water repellent sealer (Line Item #16), however the product offers a reduced level of protection. We recommend that traffic bearing membrane be provided at the pour strips over the inverted tee girders at the turning bays (Line Item #12), at a minimum, due to the more deteriorated conditions that are occurring in these areas.

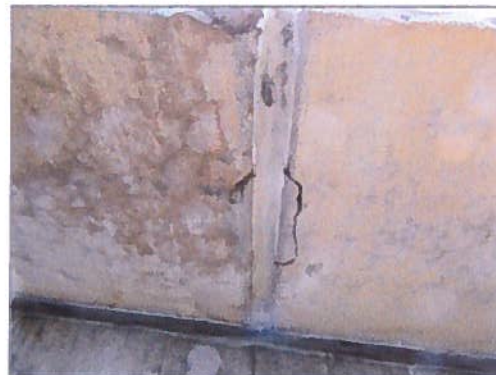
FAÇADE PANEL SPALL AT CONNECTION

Several spalls have developed at the wall panel joints around the roof level of the garage, indicating some corrosion of the underlying connection has developed. The spall leads to cracking which allows moisture penetration and increased the rate of corrosion.

We recommend providing concrete patch repair at the spalled concrete (Line Item #6), including cleaning and painting underlying steel connection with protective, rust inhibitive coating. The patch should be coated with a façade waterproofing coating (included in cost for line item #6) to help protect the underlying connections.

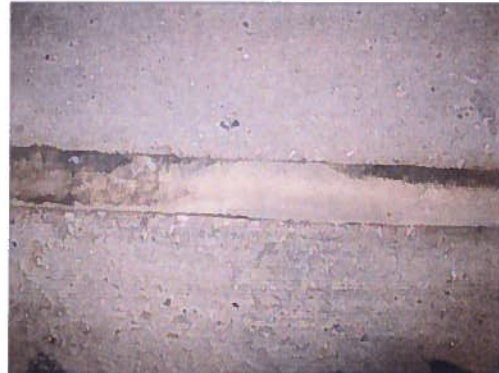
AGED AND DEBONDED TEE JOINT SEALANT

The tee-tee joint sealants are near the end of their useful service life. The sealants were beginning to debond and leak, especially at the locations of the tee-tee shear connectors. Leakage through the slab causes the embedded connectors to corrode, and deterioration of the concrete tee flange edges.

We recommend complete replacement of all of the floor slab sealants throughout the garage (Line Item #9/#14). This can be done on a scheduled basis over a few years to reduce annual budget impacts if needed.

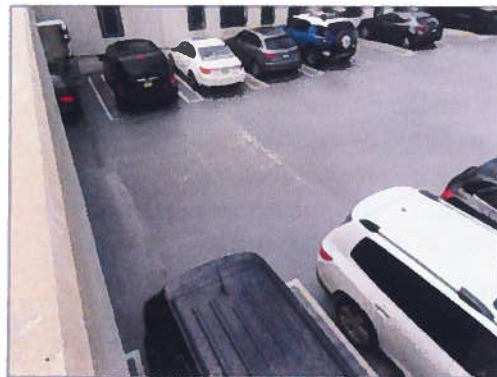
WORN MEMBRANE ALONG TEE JOINTS AND DRIVE LANES

The existing traffic bearing waterproofing membrane at the roof level is showing signs of wear, especially along tee joints and in the drive aisle. In some areas, the membrane has worn to bare concrete and the slabs and joints are vulnerable to water absorption and leakage.

We recommended the existing waterproofing membrane at the roof level be rehabilitated with a new waterproofing wear course, including a new reinforced detail base coat along the tee-tee joints (Line Item #11).

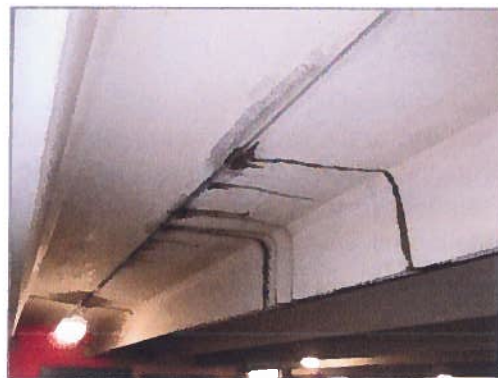
THRU SLAB LEAKAGE ALONG TEE JOINTS

Leakage at the tee-tee joints has occurred due to failed sealants & worn waterproofing. Leakage through the slab causes the embedded connectors to corrode, and deterioration of the concrete tee flange edges.

We recommend removal and replacement of the tee-tee joint sealants (Line Item #9/#14). Sealant replacement at the roof level will require replacement of traffic bearing membrane in strips along the tee joints and the new sealants as part of the work, as the existing membrane will be damaged upon removal of the existing sealants.

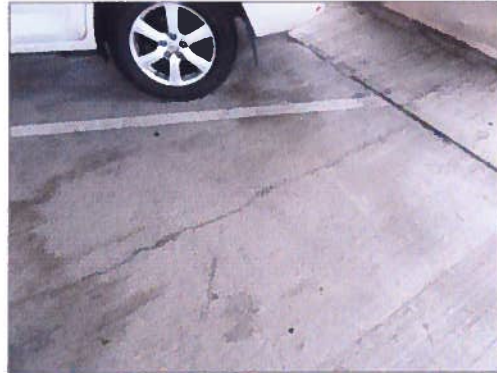
FLOOR SLAB CRACKING

Several floor slab cracks were observed throughout the garage. Slab cracks are conduits for water seepage into the slab, which can lead to corrosion of reinforcing steel and subsequent concrete delaminations and spalls.

We recommend routing and sealing the floor slab cracks (Line Item #10) with new polyurethane sealant to prevent the ingress of moisture into the cracks.

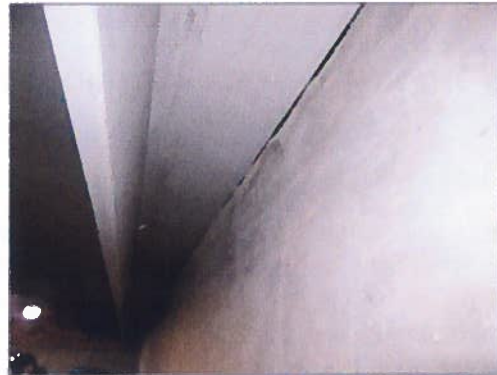
SLAB DEFLECTION AT SUPPORTED TO SOG TRANSITION

Floor slab deflections and audible noise was reported and noted as vehicles passed over the last double tee flange at transition between supported slab to slab-on-grade. There were no visible flange supports along the edge of the double tee.

We recommend providing new supplemental steel supports between the underside of the tee flange and foundation wall (Line Item #20). These will firmly support the tee flange and reduce deflections and associated noise.

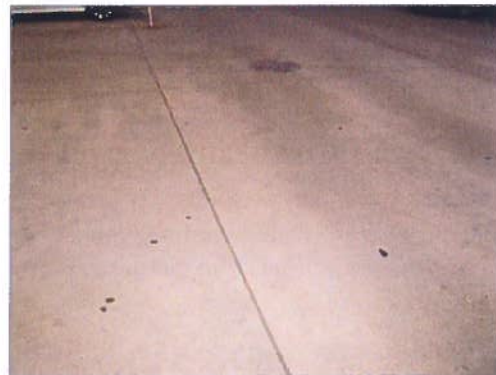
SCALING (FREEZE-THAW) DAMAGE AT SLAB-ON-GRADE

Moderate scaling was observed at the SOG slab, especially at the vehicle entrance/exit. Although not a structural concern at this time, the scaling damage will eventually unravel the concrete and it will need to be repaired or replaced.

We recommend shotblast cleaning the slab and sealing it with a water repellent penetrating surface sealer (Line Item #16). The sealer will reduce the amount of moisture absorption into the slab, protecting it from freeze-thaw damage & weathering.

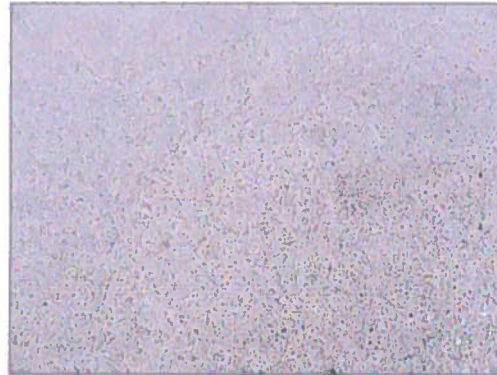
WORN WATERPROOFING MEMBRANE WEAR COURSE – ROOF LEVEL

The traffic bearing waterproofing membrane wearing course is showing signs of moderate wear, including loss of some of the embedded aggregate.

We recommend resurfacing the roof level membrane with a new waterproofing wear course sometime within the next 1 to 3 years (Line Item #11). At the tee joints, we recommend providing a new reinforced detail base coat.

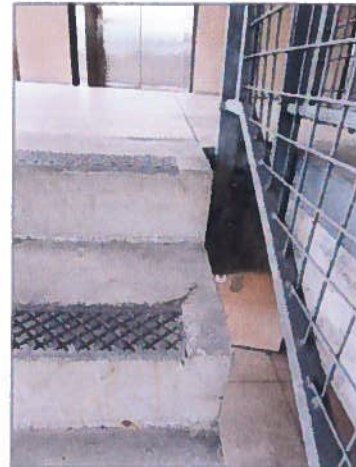
STAIR TREAD EDGE SPALLS

Crack and spalled tread edges were observed at most of the stairs. These spalls may eventually come loose and become a tripping hazard, as well as be unsightly.

We recommend that the spalled edges be patch repaired (Line Item #7).

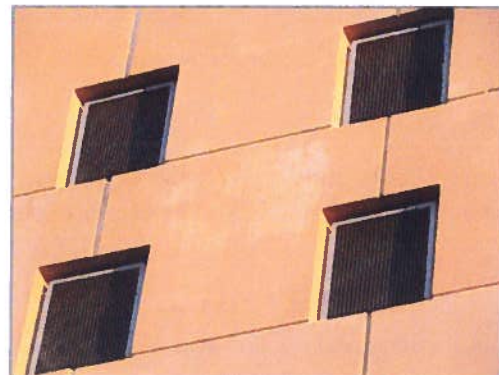
CRACKING/SPALLING AT PRECAST CONCRETE FAÇADE PANEL

A few cracks, previous patches, and potentially new spalls have developed at the precast façade panels. The condition appeared to be limited to the top row of precast concrete panels.

Cracks and spalls appeared to be minimal at this time, and should be monitored for development of loose & spalled concrete.

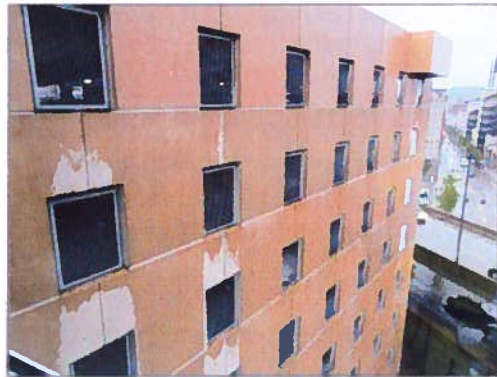
WET/SATURATED FAÇADE

Water absorption into the façade panels was occurring at the time of our visit, indicating that a serviceable waterproofing sealer is not currently protecting the façade panels.

We recommend the façade be powerwash cleaned and sealed with a protective water repellent sealer (Line Item #17).

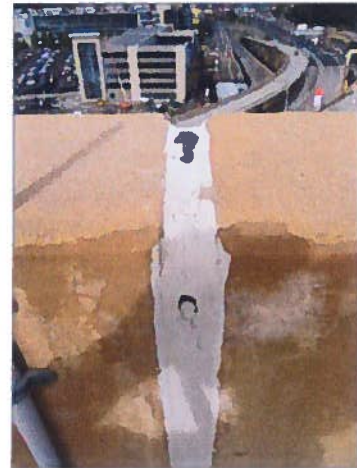
CRACKED AND DEBONDED SEALANT AT FAÇADE PANELS

Some of the façade sealant has debonded and failed. The open joints allow water to seep into the joints causing corrosion of embedded steel connections and concrete delaminations around panel connections.

This condition is relatively sporadic at this time, however is an indication that the façade sealant is nearing the end of its useful service life. We recommend removal and replacement of the façade sealants sometime in the next 1 to 3 years (Line Item #15).

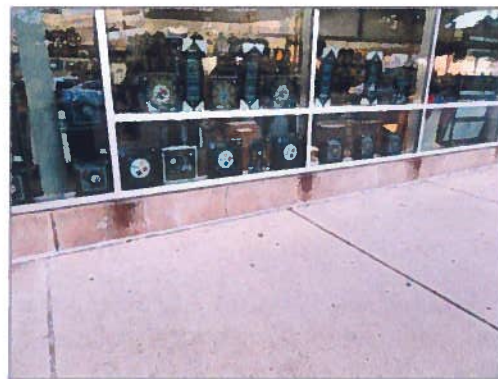
FOUNDATION WALL CRACKS

Several foundation wall cracks were observed, a few of which appear to have been previously routed but were never sealed.

We recommend routing and sealing the cracks at the exposed portion of the foundation wall (Line Item #10).

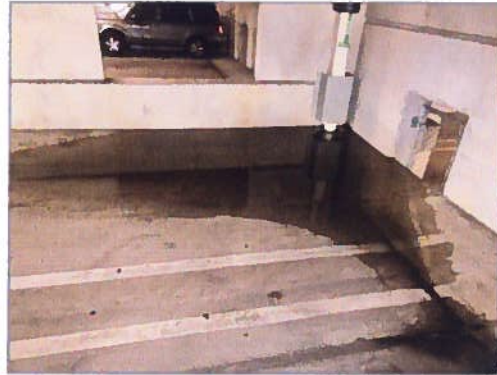
CLOGGED DRAIN/WATER PONDING

We observed at least one area of water accumulation/ponding due to a clogged drain.

We recommend inspecting and clean out the drainage system as needed (Line Item #19).

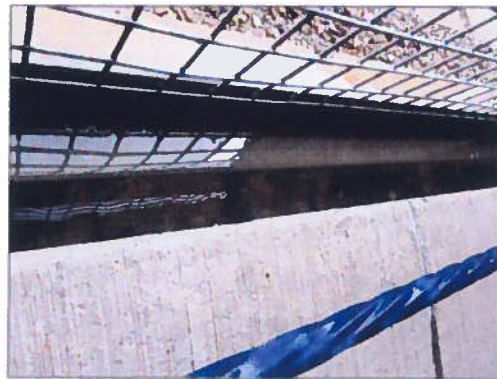
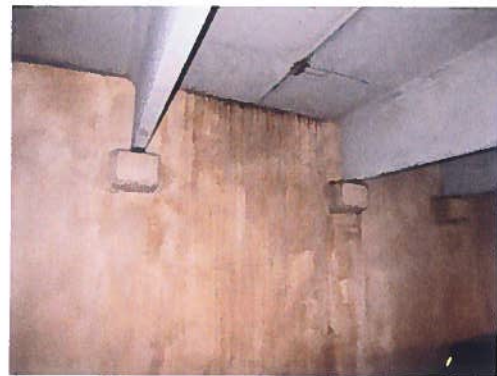
LEAKAGE BELOW SELECTED WALL OPENING, LEVEL 3 NEAR CL 3.

We observed water accumulation between the slab and a wall opening. The water was leaking between the slab joint with the façade and running down the foundation wall.

Parge and flash the wall opening to drain water away from the floor slab (Line Item #18).

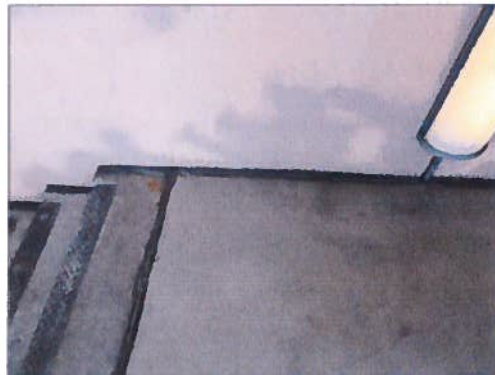
FAILED SEALANTS AT STAIRS

The existing sealants at the stairs have failed allowing water into the joints between the sections of the precast stairs; leading to corrosion damage of the structural precast connections.

Remove and replace the caulk sealants (Line Item #9/#14) to protect the precast connections.

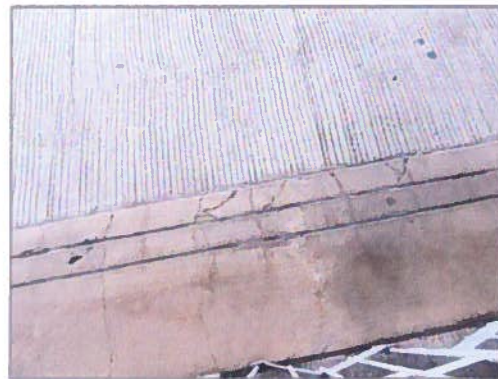
CRACKING OF TOPPING AT SPEED RAMP TO GARAGE POUR STRIP

The cast-in-place concrete pour strip between the floor slab and exterior speed ramp has cracked and may have spalled (direct access was not available to the ramp at the time of our survey).

We recommend sounding and providing patch repairs (Line Item #4) as needed. Rout and seal cracks (Line Item #10) at the pour strips and coat with a new waterproofing membrane.
